November 2007 Construction Update

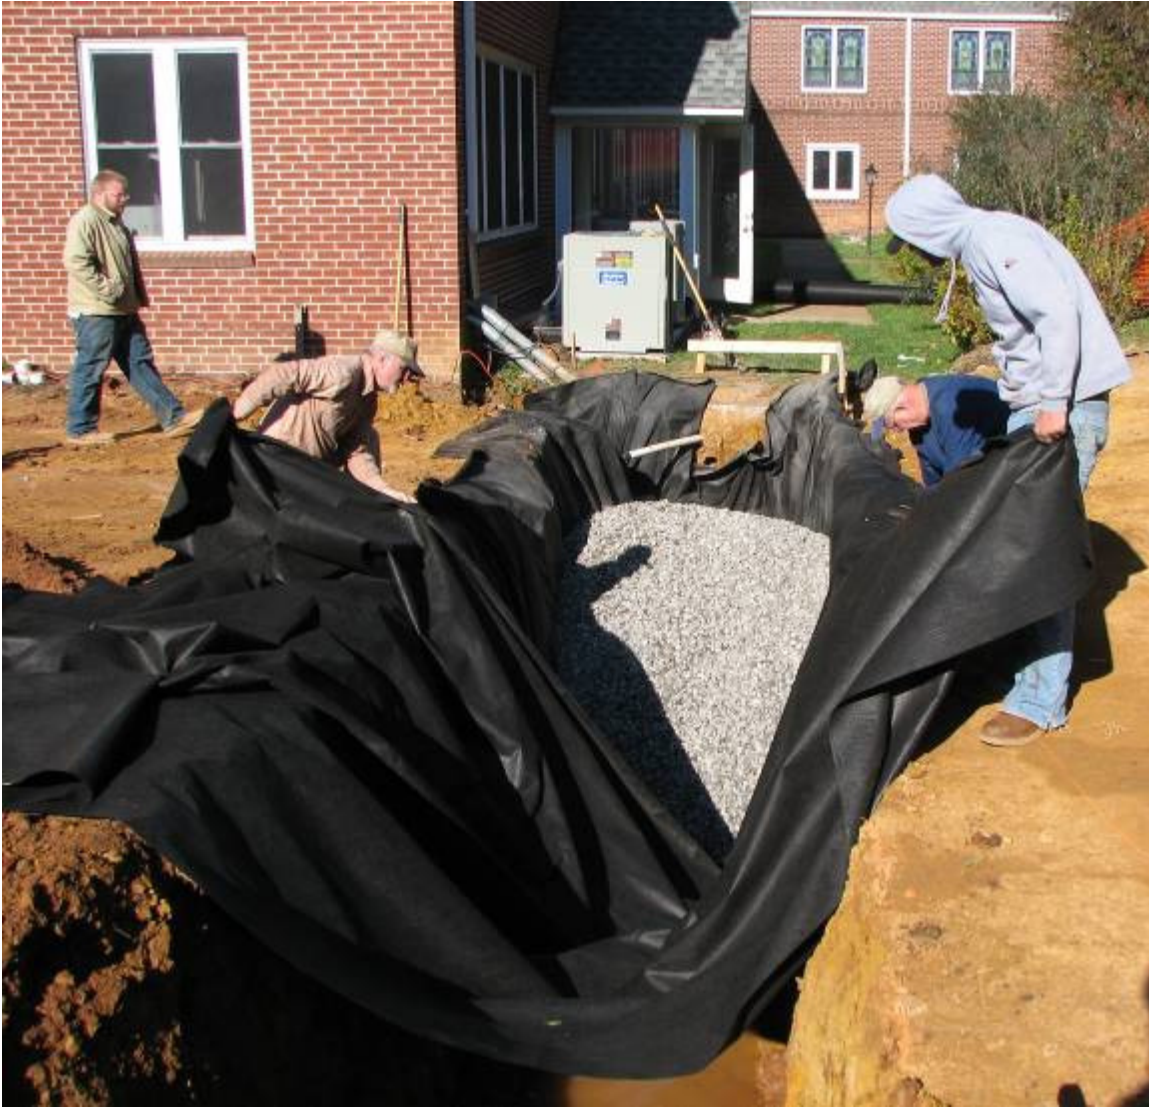
Robbie, Earl and construction workers manipulate the black fabric to line the trenches which will hold the crushed stone. Note the water in the bottom of the trench. It has to be pumped out.

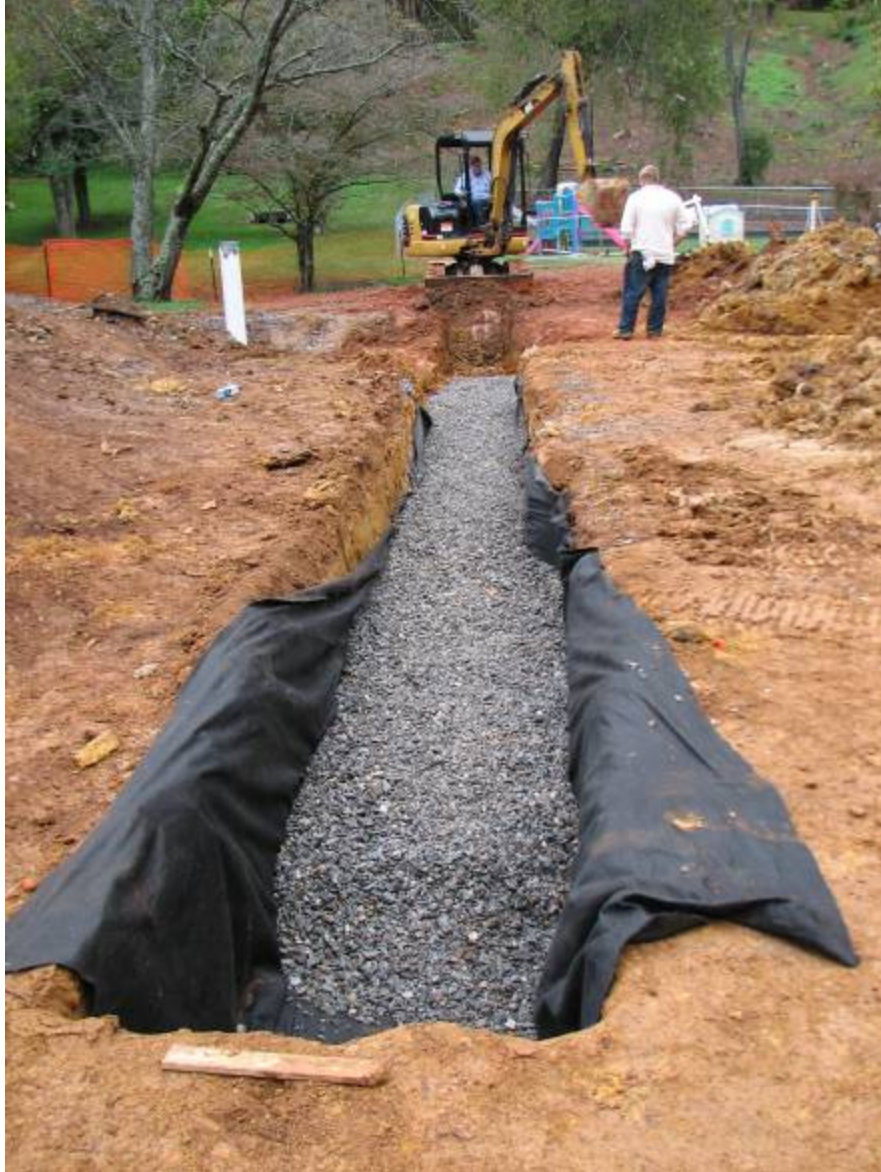
When trenching is done, cement will be poured over the crushed stone for the foundation.

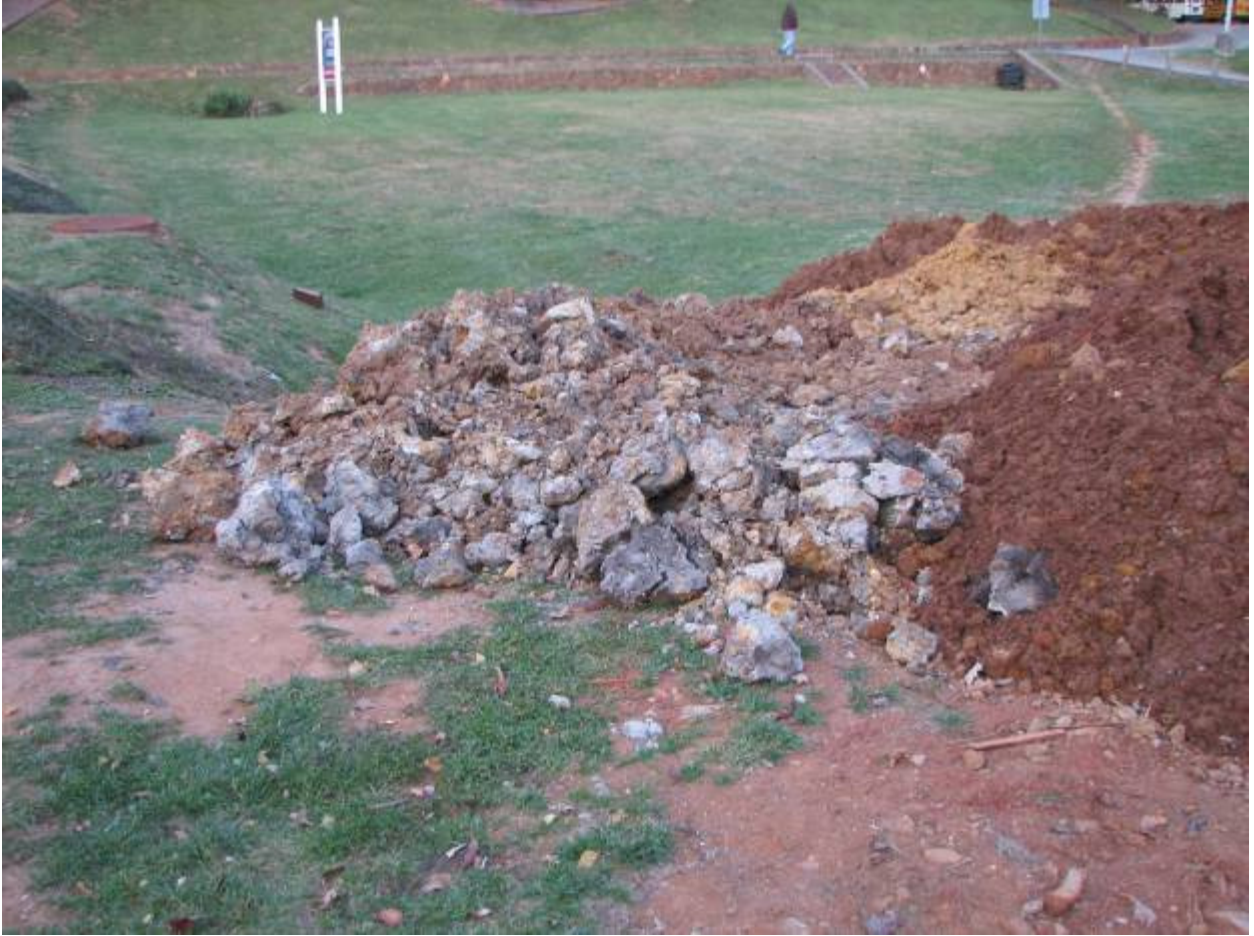
The white clay in this picture is bad soil which has been removed from the trenches. White clay is the silt from the pond that used to be the parking lot many years ago. White clay is not stable soil. In some places during the digging, walls caved in due to the unstable white clay.

Core samples were drilled and engineers have evaluated the situation. In some places on our site, the white clay has been removed and in other places a steel grid will be put in place to prevent shifting of the soil. To compound problems, the water table is 4' below ground level and needs to be pumped out as the black matting and crushed stone is added.

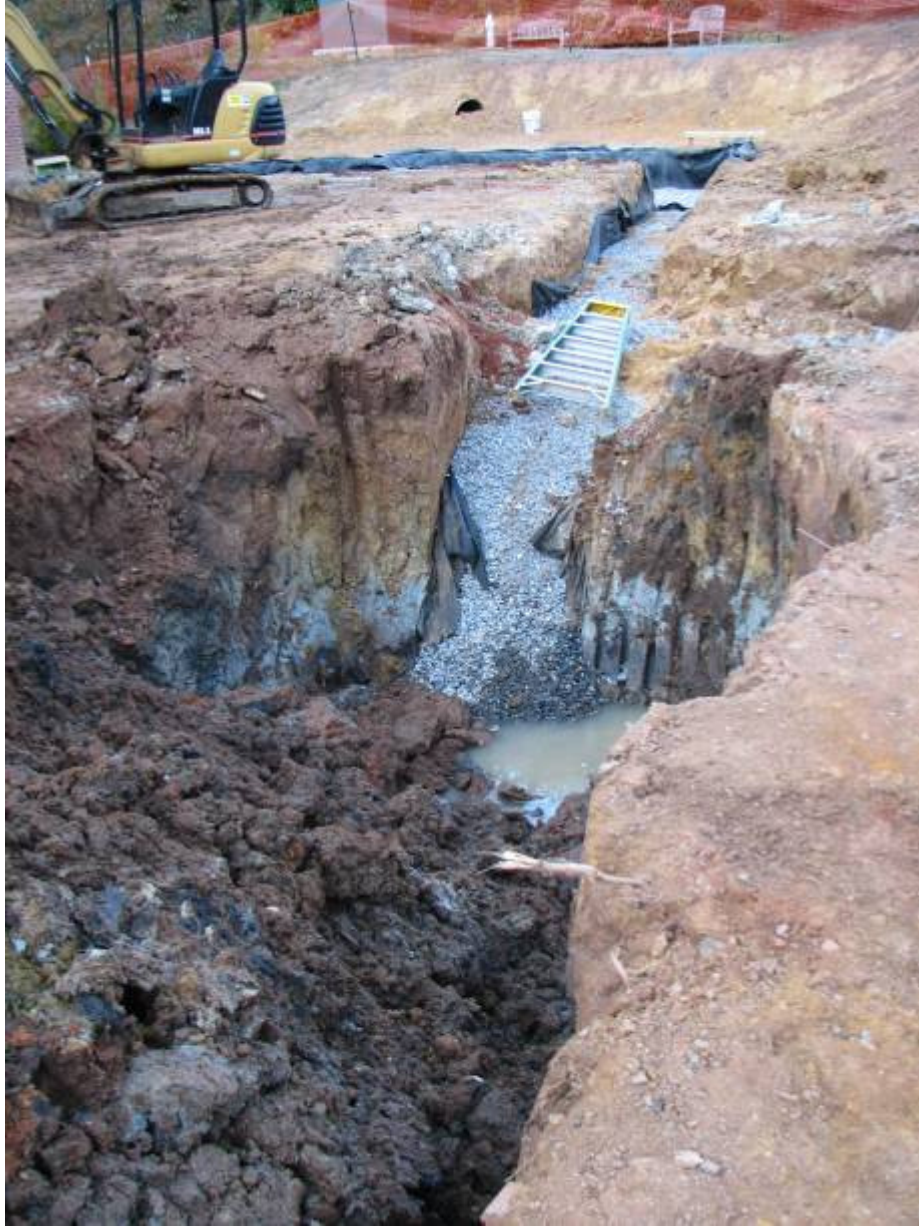
It certainly was neither a good day nor good news when this trench wall caved in.
